RESEARCH NOTES

February 2003 GRG Vol.1, No.3

Corridor-Scale Landslide Hazard Maps Provide "Big Picture" for Planning and Mitigation

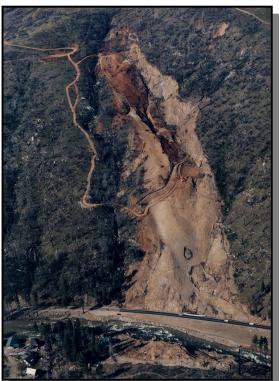
Figure 2 - 1997 Mill Creek Slide on Route 50.

Figures 1 and 2 illustrate the value of broader context regarding landslide hazards. Figure 1 highlights the extent of the 1997 Mill Creek Slide (Fig. 2) which closed Route 50 for approximately one month. Note that the yellow areas in Fig. 1 represent additional landslide features. This map was prepared by the California Geological Survey (CGS) as part of the emergency response and recovery from the 1997 incident, and now serves as a planning and maintenance document for developing long-term mitigation strategies. Recognizing the value of this product, Caltrans geotechnical engineers solicited assistance from the GeoResearch Group (GRG) to develop product standards using experience gained from slide mapping of selected highway corridors within a variety of climatological and geological settings.

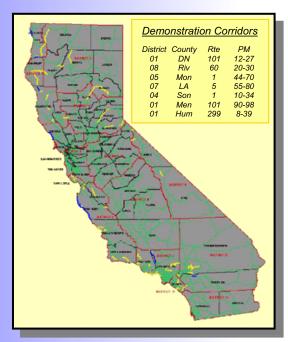
To assure that the CGS work met Caltrans' user needs, the GRG established a "Project Advisory Panel" (PAP), consisting of Caltrans geo-professionals and various District representatives to help guide the project. Initially, the PAP helped assemble a list of over 1200 miles of slide-prone highway corridors based on Caltrans' project experience. The PAP also aided prioritization of 147 route miles along seven corridors in five Districts for mapping under this research-funded demonstration project. Selection criteria included route importance, diversity of Districts, and assuring that a representative variety of geologic and climatological environments were considered. Figure 3 shows slide-prone corridors in yellow, and the selected demonstration sites in blue.

Figure 3 - Landslide-Prone Highway Corridors
